**Subject: Emergency Response Trip Report and Removal Site Evaluation
 Park Warehouse Fire Site, St. Louis, Missouri
 U.S. EPA Region 7 START 4, Contract No. EP-S7-13-06, Task Order No. 0203
 Task Monitor: Heath Smith, EPA On-Scene Coordinator**

**EMERGENCY RESPONSE TRIP REPORT AND REMOVAL SITE EVALUATION
PARK WAREHOUSE FIRE, ST. LOUIS, MISSOURI**

**Superfund Technical Assessment and Response Team (START) 4 Contract
Contract No. EP-S7-13-06, Task Order No. 0203**

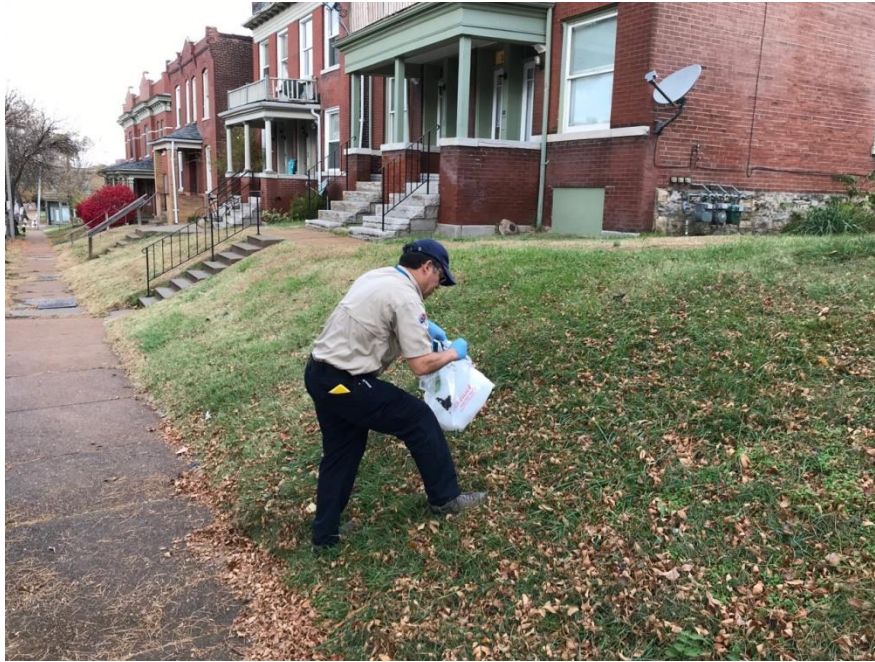
Photo No.: 59	Date: 11/18/2017	Time: 08:50
Photographer: Greg Blattner		Direction: West
Latitude: 38.62040	Longitude: -90.24338	
Description: This photograph shows debris sample WF-T1-014 collected from residential neighborhood near Park Warehouse.

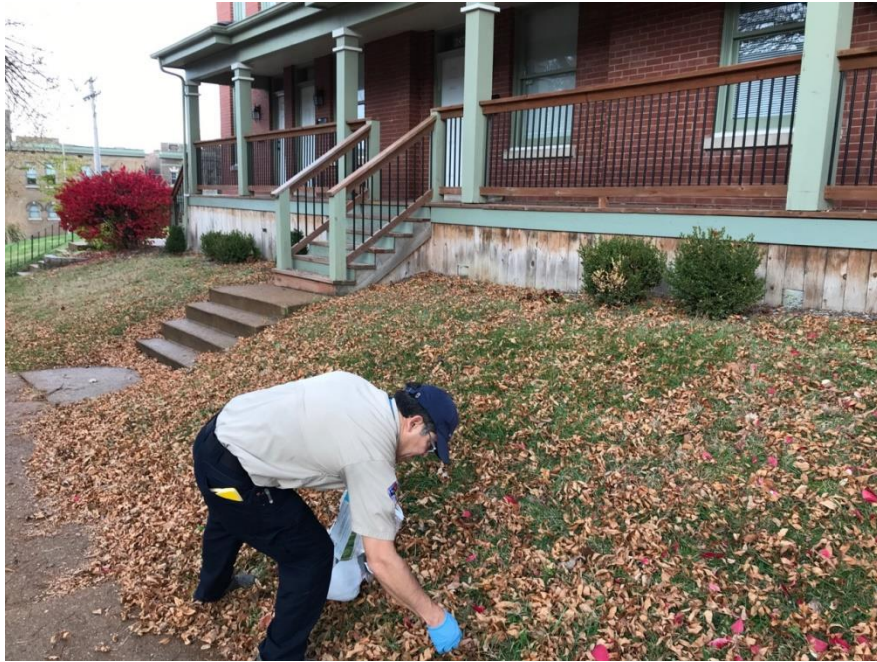
Photo No.: 61	Date: 11/18/2017	Time: 08:55
Photographer: Greg Blattner		Direction: Northwest
Latitude: 38.62044		Longitude: -90.24387
Description: This photograph shows debris sample WF-T1-015 collected from residential neighborhood near Park Warehouse.

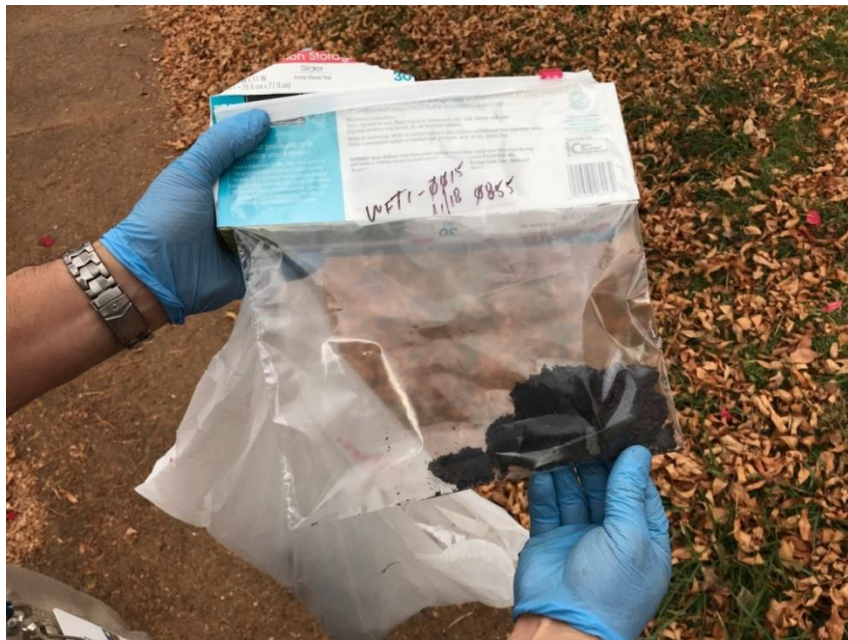
Photo No.: 62	Date: 11/18/2017	Time: 08:55
Photographer: Greg Blattner		Direction: Northwest
Latitude: 38.62044	Longitude: -90.24387	
Description: This photograph shows debris sample WF-T1-015 collected from residential neighborhood near Park Warehouse.

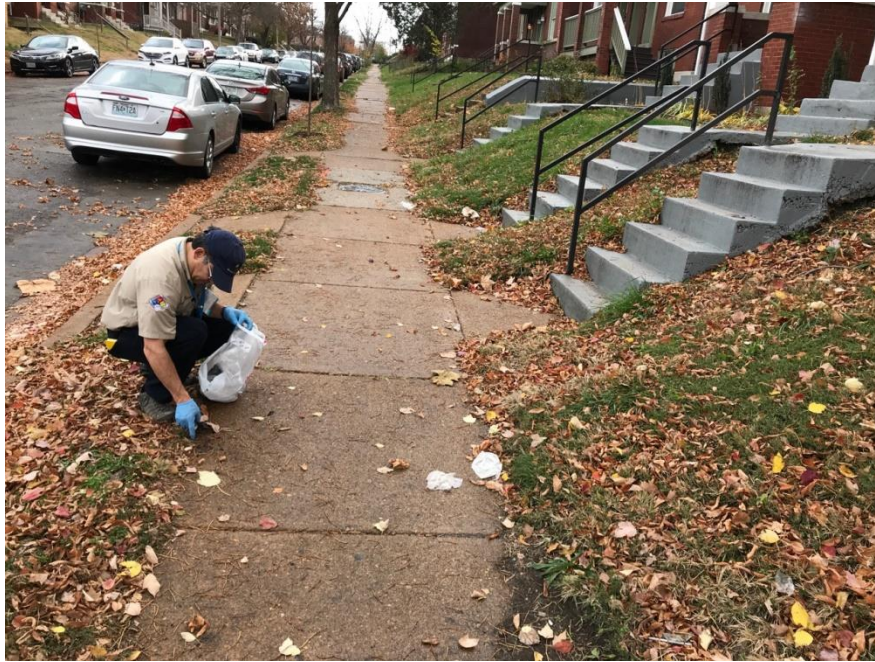
Photo No.: 63	Date: 11/18/2017	Time: 09:00
Photographer: Greg Blattner		Direction: East
Latitude: 38.62029	Longitude: -90.24424	
Description: This photograph shows debris sample WF-T1-016 collected from residential neighborhood near Park Warehouse.

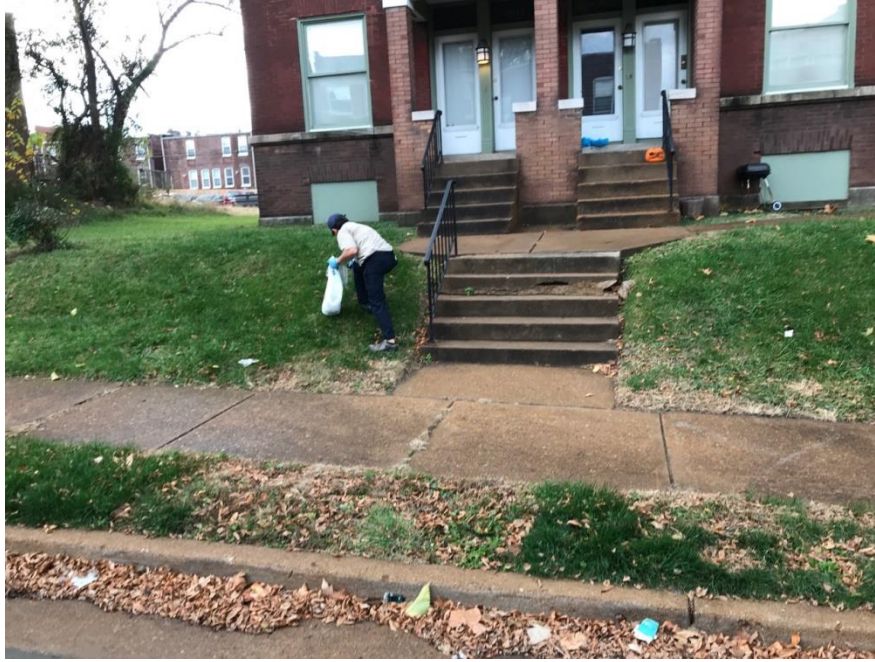
Photo No.: 65	Date: 11/18/2017	Time: 09:03
Photographer: Greg Blattner		Direction: Southeast
Latitude: 38.62026		Longitude: -90.24379
Description: This photograph shows debris sample WF-T1-017 collected from residential neighborhood near Park Warehouse.

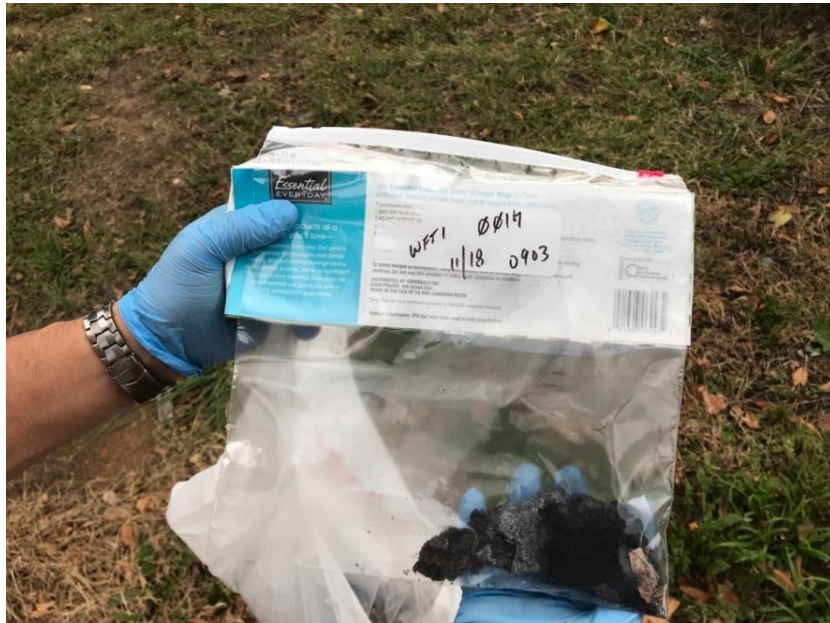
Photo No.: 66	Date: 11/18/2017	Time: 09:03
Photographer: Greg Blattner		Direction: Southeast
Latitude: 38.62026	Longitude: -90.24379	
Description: This photograph shows debris sample WF-T1-017 collected from residential neighborhood near Park Warehouse.

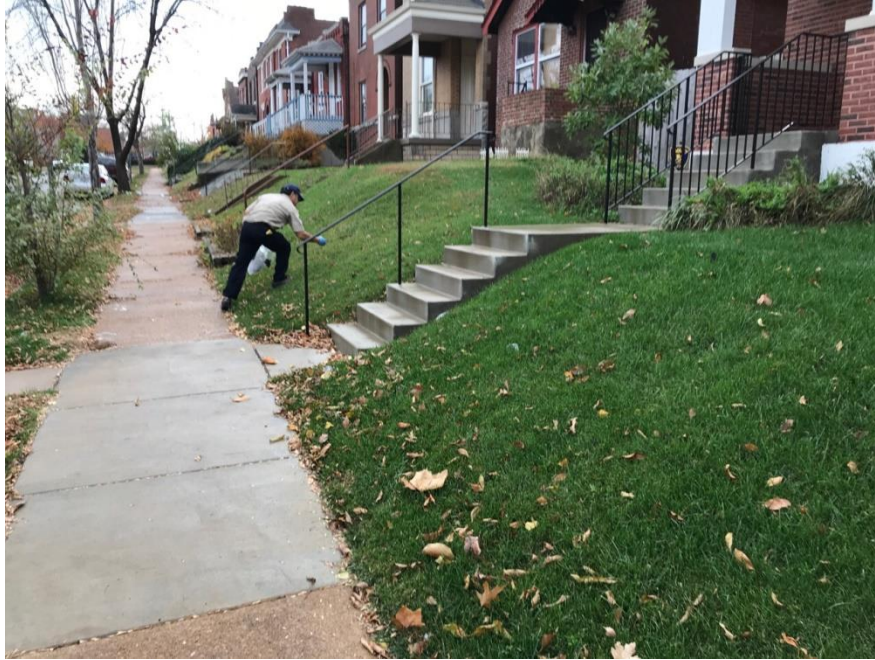
Photo No.: 67	Date: 11/18/2017	Time: 09:05
Photographer: Greg Blattner		Direction: East
Latitude: 38.62020		Longitude: -90.24215
Description: This photograph shows debris sample WF-T1-018 collected from residential neighborhood near Park Warehouse.

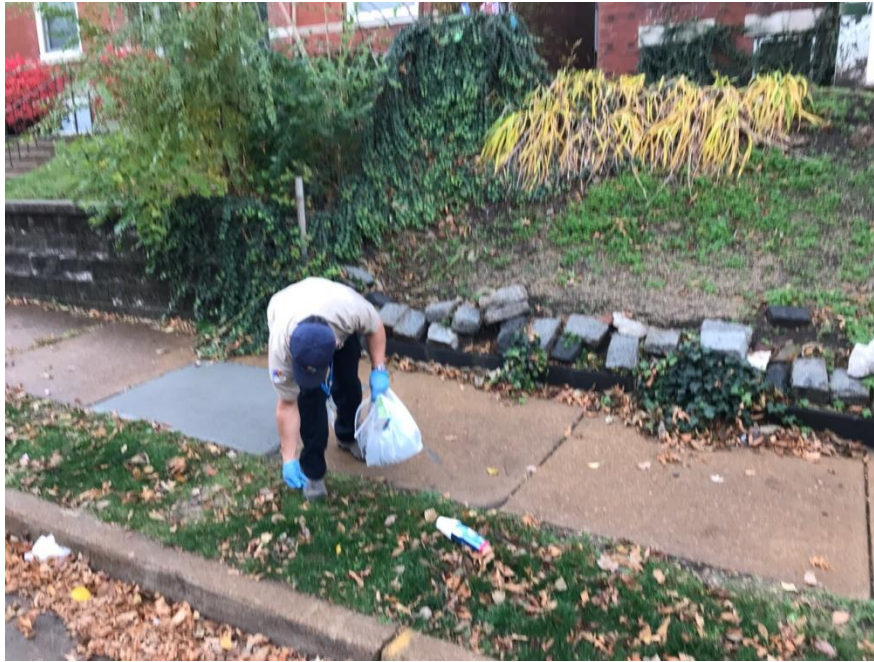
Photo No.: 69	Date: 11/18/2017	Time: 09:08
Photographer: Greg Blattner		Direction: Southeast
Latitude: 38.62015		Longitude: -90.24252
Description: This photograph shows debris sample WF-T1-019 collected from residential neighborhood near Park Warehouse.

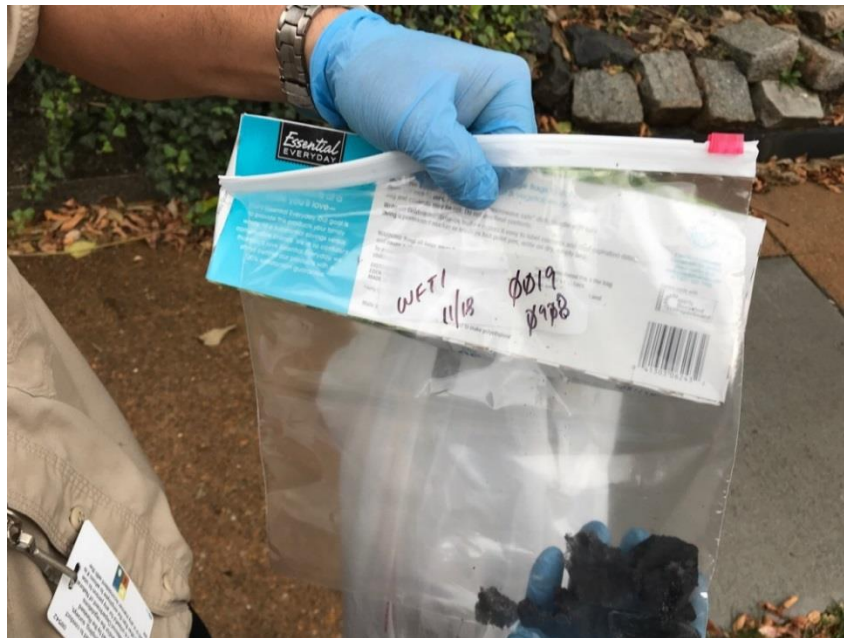
Photo No.: 70	Date: 11/18/2017	Time: 09:08
Photographer: Greg Blattner		Direction: Southeast
Latitude: 38.62015		Longitude: -90.24252
Description: This photograph shows debris sample WF-T1-019 collected from residential neighborhood near Park Warehouse.

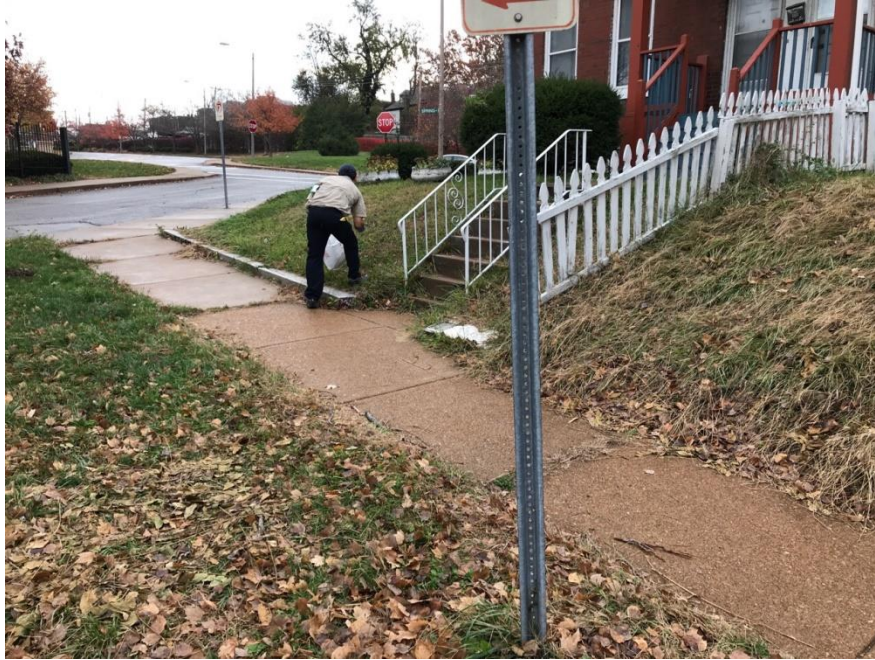
Photo No.: 71	Date: 11/18/2017	Time: 09:10
Photographer: Greg Blattner		Direction: Southeast
Latitude: 38.62013		Longitude: -90.24215
Description: This photograph shows debris sample WF-T1-020 collected from residential neighborhood near Park Warehouse.

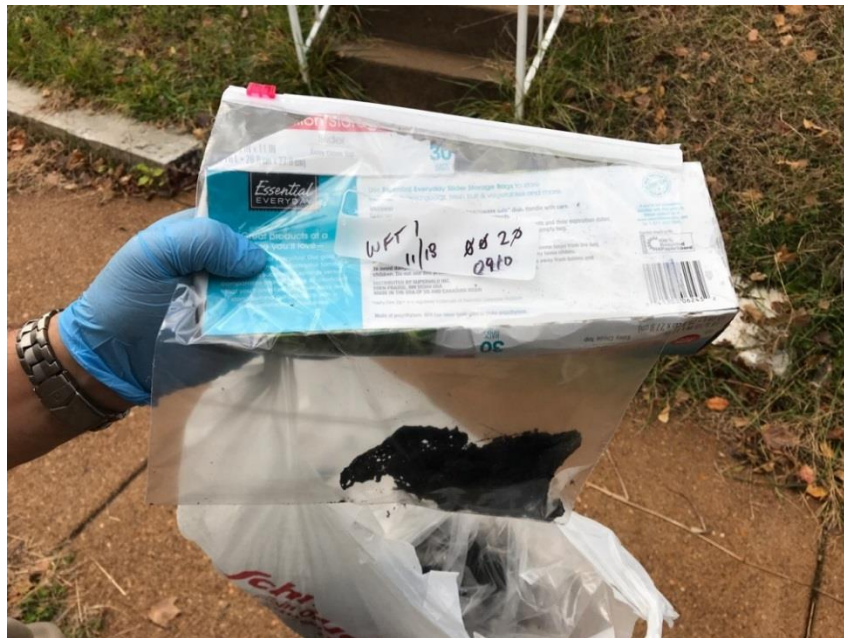
Photo No.: 72	Date: 11/18/2017	Time: 09:10
Photographer: Greg Blattner		Direction: Southeast
Latitude: 38.62013		Longitude: -90.24215
Description: This photograph shows debris sample WF-T1-020 collected from residential neighborhood near Park Warehouse.
